TRW MATERIALS COMPATIBILITY STUDY WITH
ETHYLENE OXIDE/FREON 12 DECONTAMINATION PROCESSES

CONTRACT NO. NAS8-20864

TRW No. 09133-6003-R000

September 14, 1967

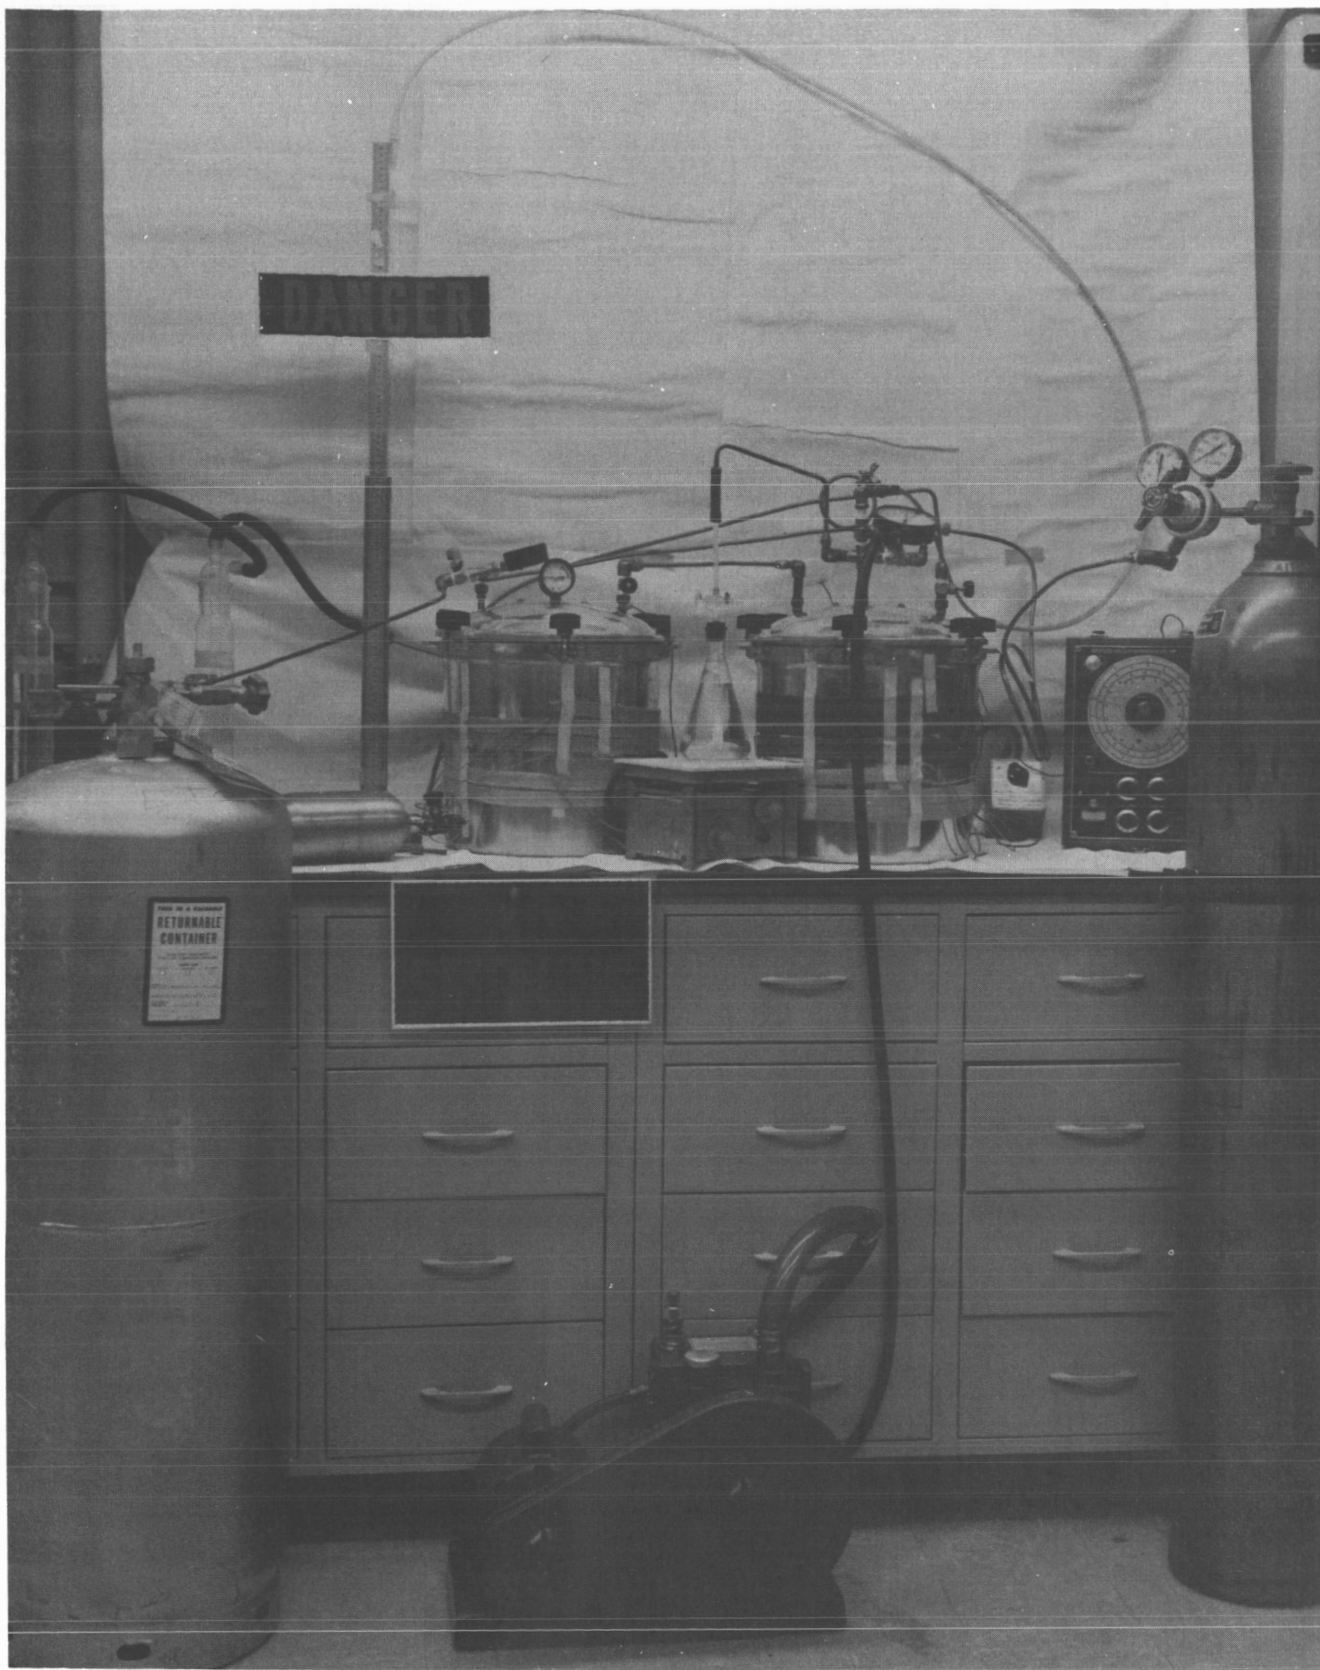
FIGURE 1. Decontamination Set-Up Color Photo.

The compatibility studies were conducted in 2 pressure cooker type sterilizers commercially available in 24 liter capacities. These sterilizers are capable of withstanding at least 100 psi (burst pressure) and are equipped with automatic safety relief valves when pressures greater than 30 psia are experienced.

A typical test setup is shown in Figure A-1.

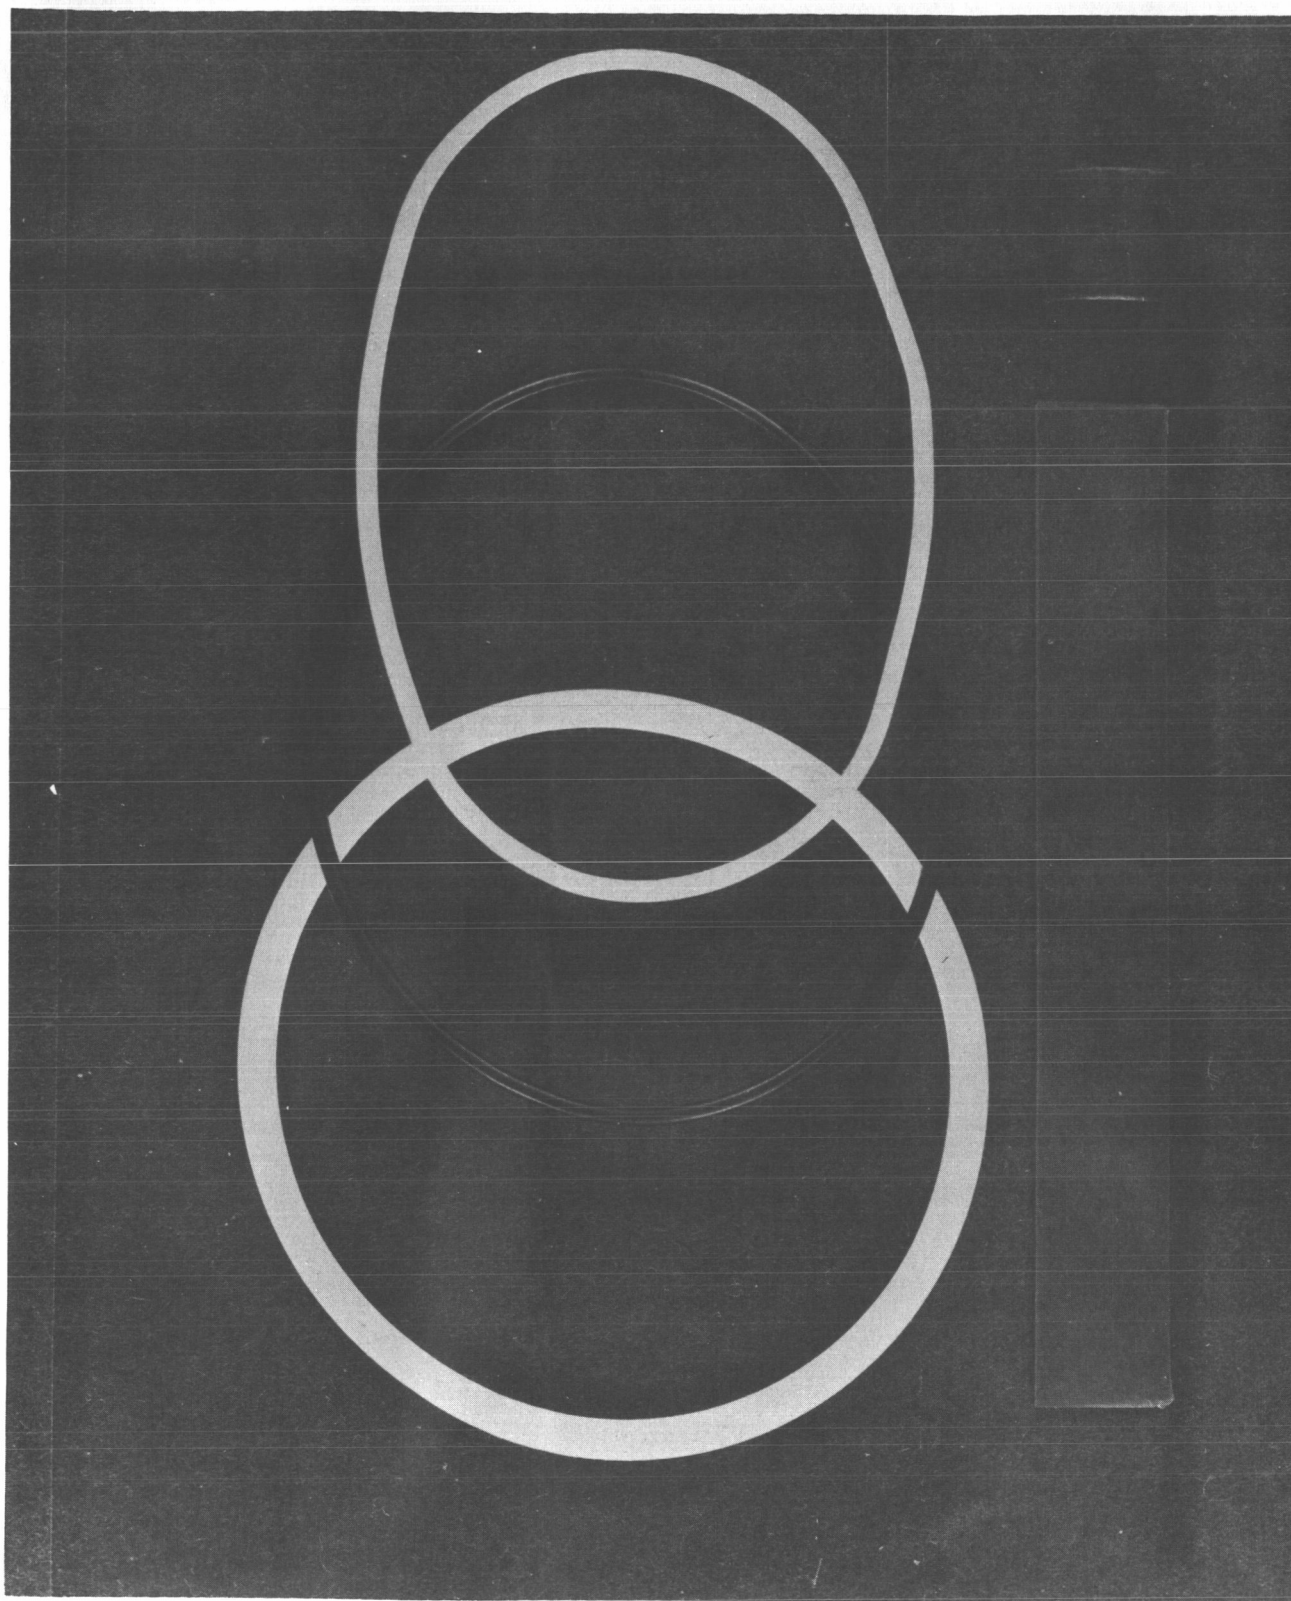
FIGURE 2. O-Rings - Teflon and Butyl - Sheet and Button pieces of Nitroso Rubber, all before ETO/Freon 12. Color Photo (Neg. #32618-67)

The changes occurring in the O-Rings that are most commonly used, i.e., Butyl Rubber, Ethylene Propylene Rubber, and Teflon, show very little degradation, if any. There were no color changes noted. (Figures 2, 3, and 4.) The weight changes were minute and dimensional changes were insignificant (See Table 2). However, in view of the fact that Butyl Rubber is temperature sensitive above about 225°F., other materials should be considered if thermal conditioning for an extended period is anticipated.

Carboxy Nitroso Rubber is definitely not suitable when decontamination cycles are required. This rubber showed gains in weight ranging from 76.5 percent to 271 percent and dimensional increases from 30.9 percent to 81.3 percent. The tensile strength decreased 80 percent, and the elongation was reduced by 51 percent. Visual changes were apparent as early as the first 28-hour cycle. The Nitroso Rubber, which was originally dark green in color, changed to light green, and displayed significant swelling and increase in volume. This phenomena continued throughout the seven decontamination cycles, and after completion, the specimens continuously oozed beads of liquid even when the rubber was wiped dry (See Tables 2 and 12, and Figures 2, 5, 6, and 7.)

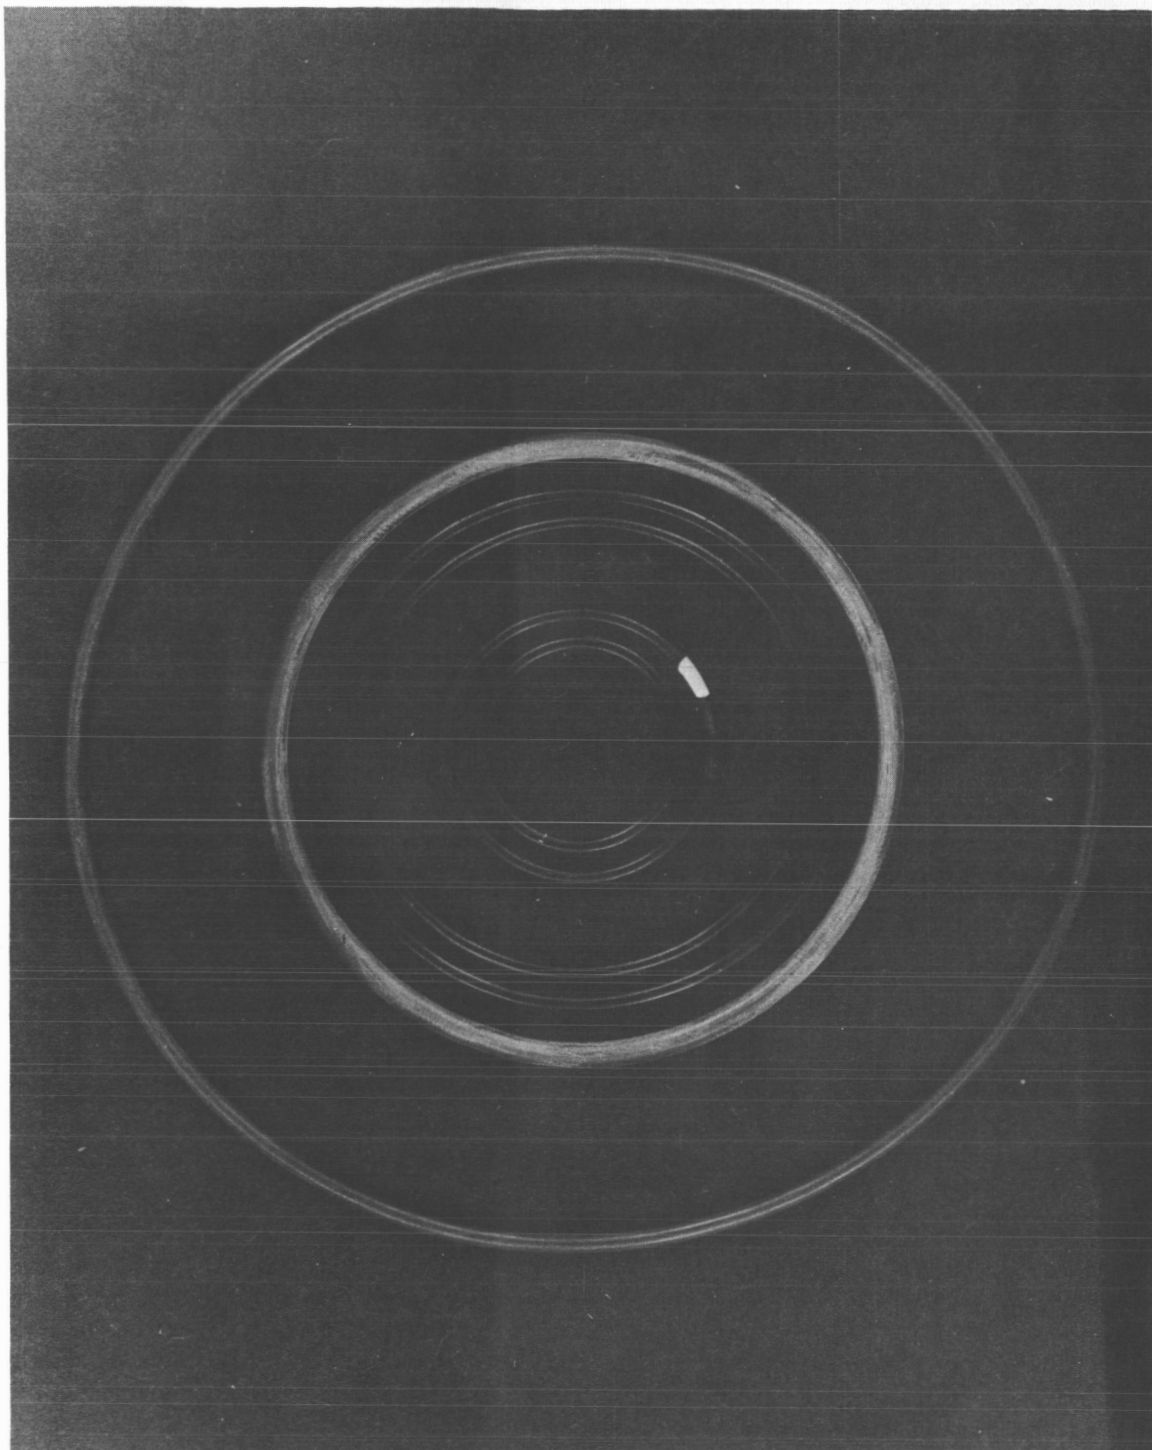
FIGURE 3. O-Rings before ET0/Freon 12. Going from the largest to the smallest - Nitrile 2-45; Nitrile 2-142; Butyl 7032-031; Butyl 7032-037; EPR (No #); EPR (No #). Color Photo (Neg. #32611-67).

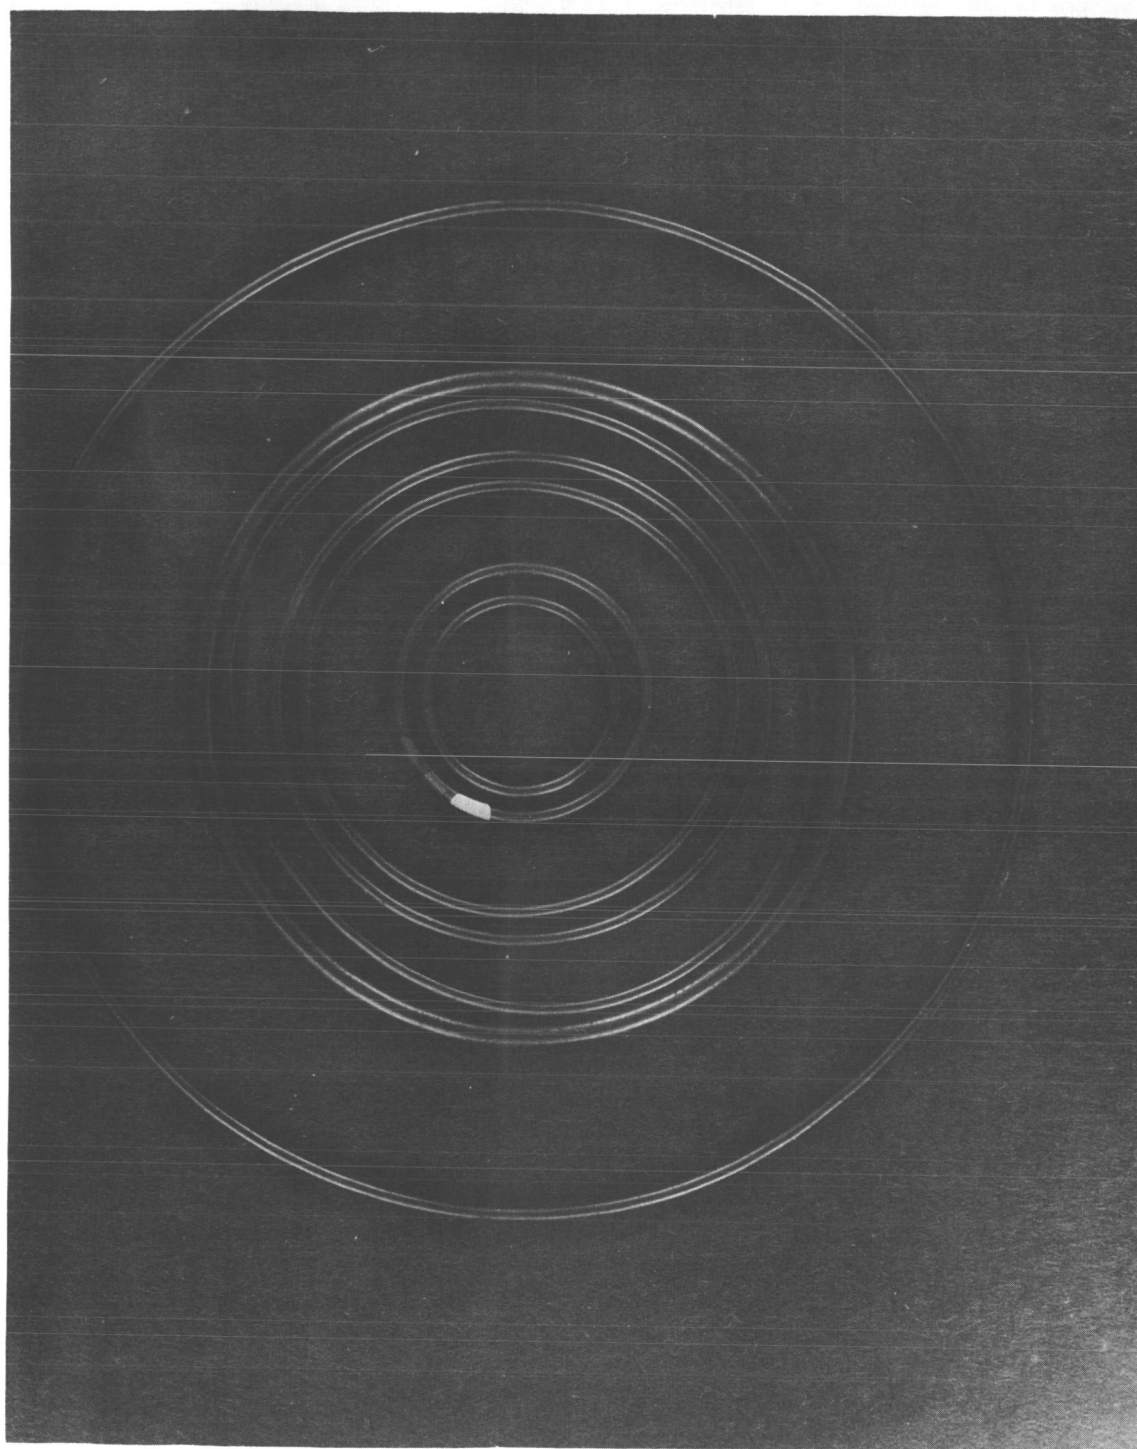
FIGURE 4. O-Rings after 7 cycles ETO/Freon 12. Going from the largest to the smallest - Nitrile 2-45; Nitrile 2-142; Butyl 7032-033; Butyl 7032-031; Butyl 7032-037; EPR (No #); EPR (No #). Color Photo (Neg. #33015-67).

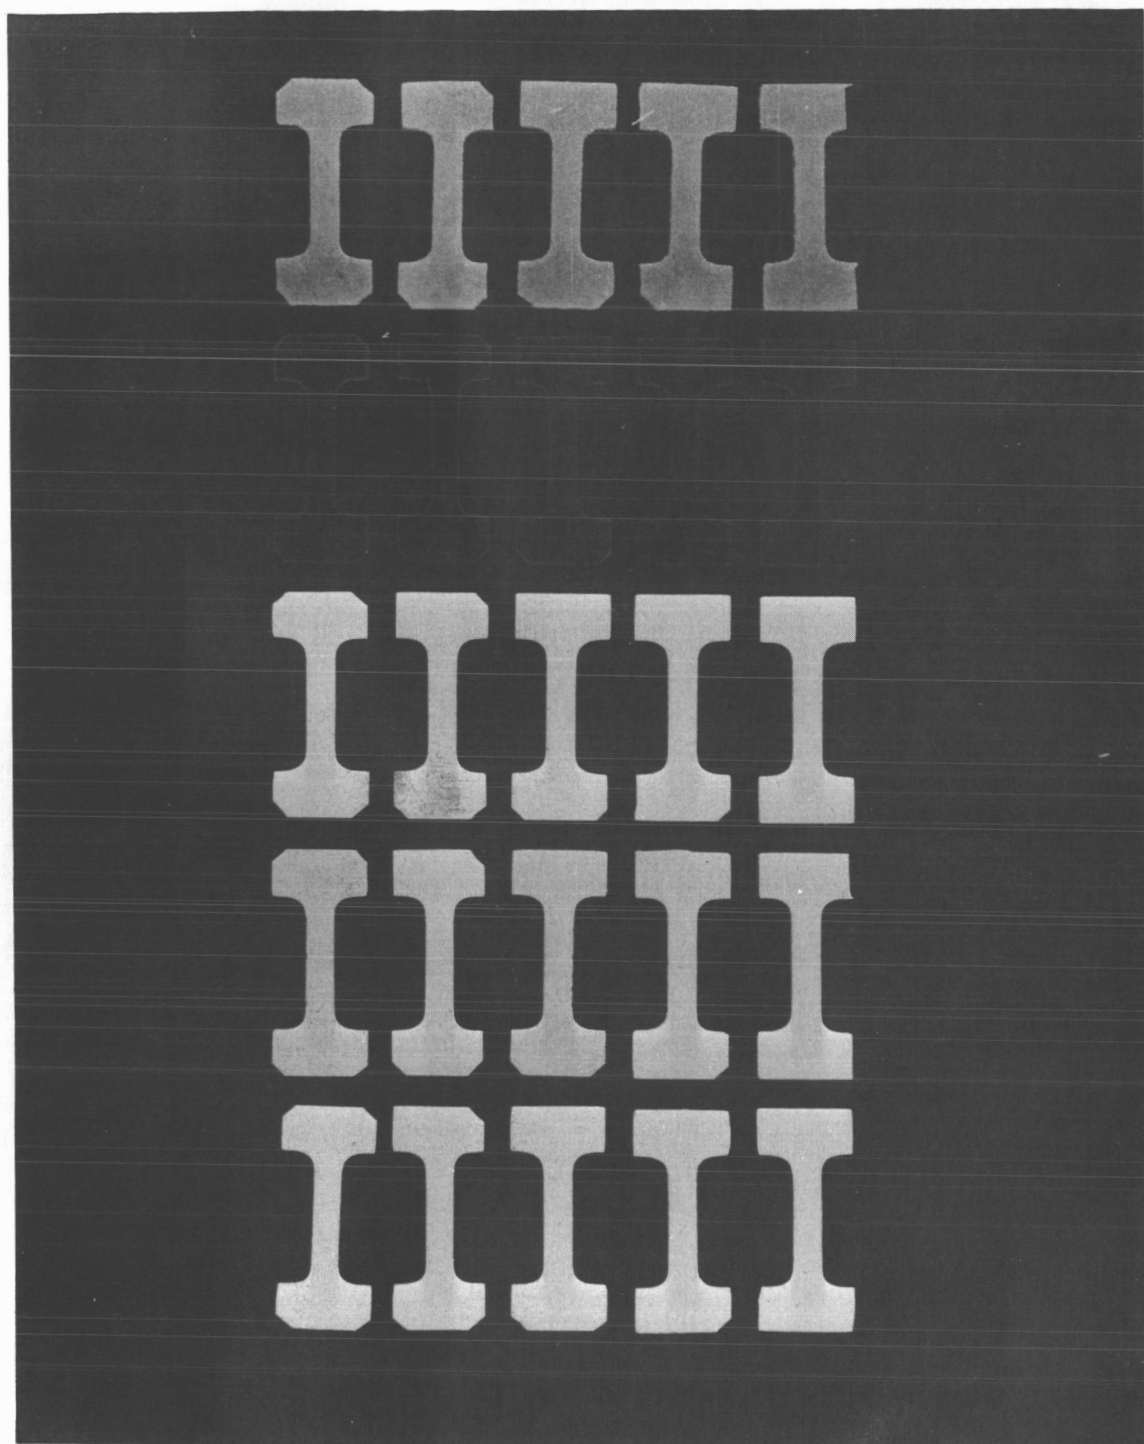
FIGURE 5. Top to Bottom - Sylgard 182 Dumbell Samples; RTV 601 Dumbell Samples; RTV GE 8111 Dumbell Samples; NT-5 Nitroso Rubber Dumbell Samples; RTV S-5370 Dumbell Samples. All before ET0/Freon 12. Color Photo (Neg. #32614-67).

The RTV Compounds (Tables 4, 13, 14, and 15, and Figures 5 and 6), in general, showed good resistance to the ETO/Freon 12 environment. Of the three RTV compounds tested, only one, RTV S-5370, a silicone foam used as a potting compound in the Shut-Off Valve showed large weight and dimensional gains (about 19.5 percent). At room temperature, tensile strength and elongation tests with RTV S-5370 showed increases of 17.3 percent and 13.1 percent.

Sylgard 182 (Table 16 and Figures 5 and 6), which is used between the combustion chamber case and ablative materials, showed significant changes in ETO/Freon 12. Losses of 87 percent in tensile strength and 4.4 percent in elongation were recorded. Weight and dimensional measurements were inadvertently missed. Photographs were taken before and after ETO/Freon 12 exposure and showed some swelling. Although significant changes occurred in this material, a simple conclusion of incompatibility cannot be drawn since in the application (Fill material between combustion chamber case and ablative material), a surface of only 0.060 inch thickness is exposed to the ETO mixture.

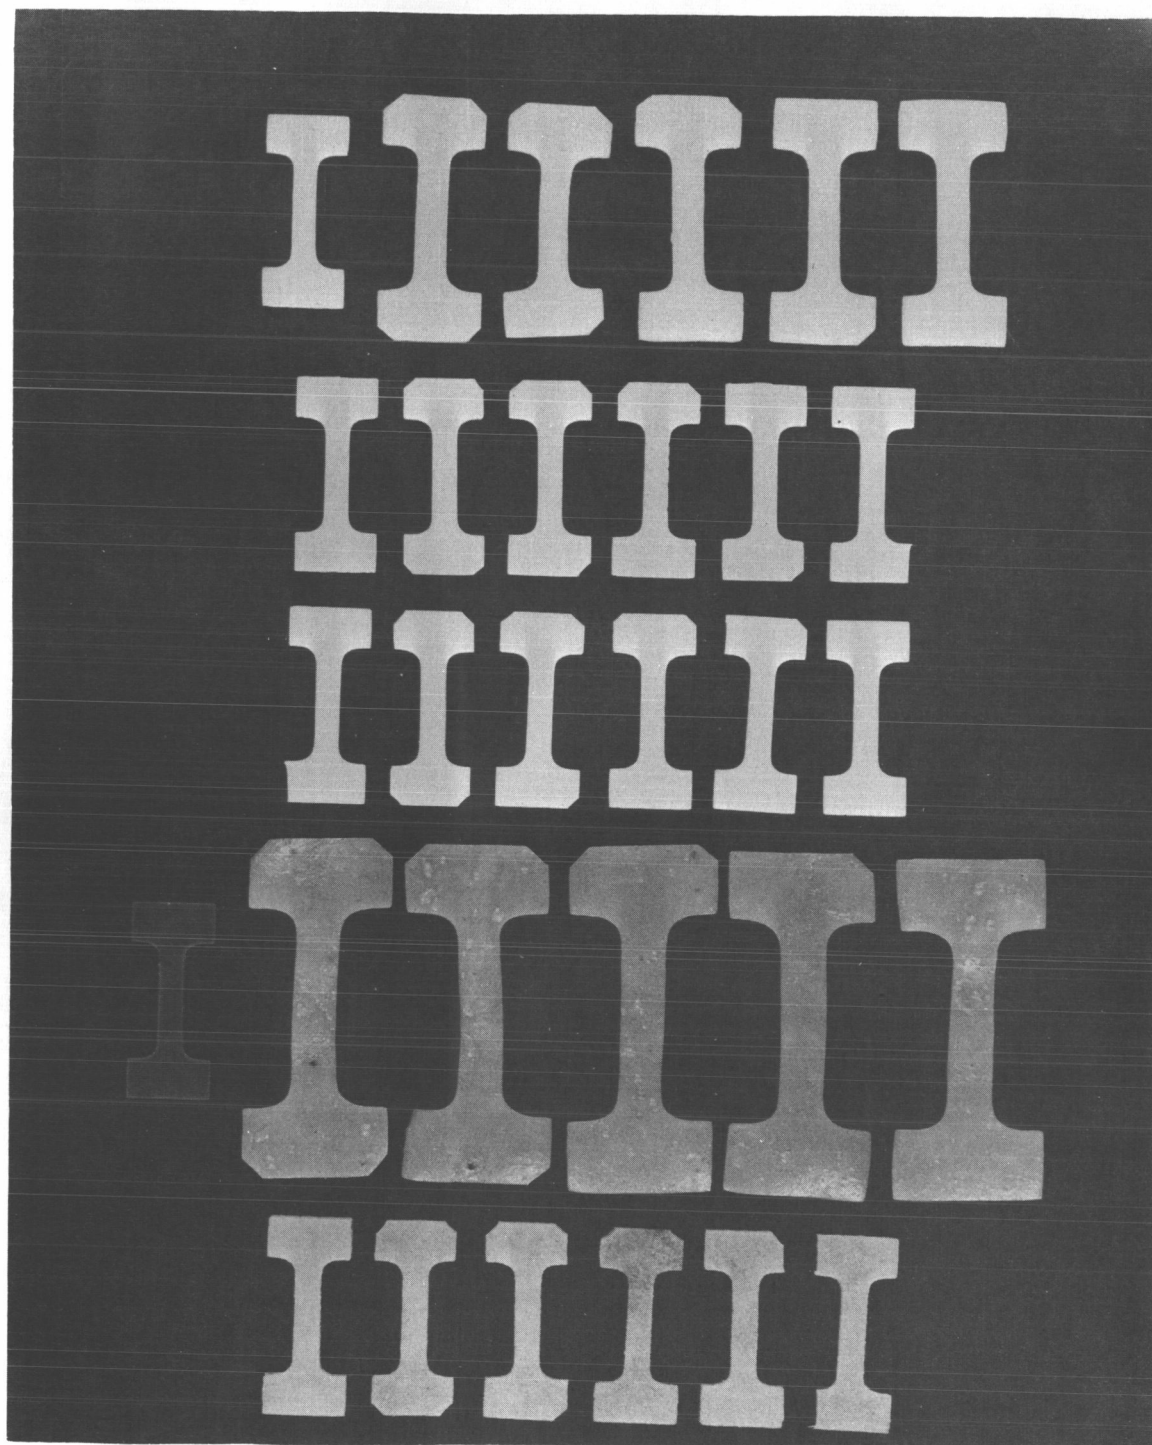
FIGURE 6. From top to bottom - Sylgard 182 Dumbell Samples; RTV 601 Dumbell Samples; RTV GE 8111 Dumbell Samples; NT-5 Nitroso Rubber Dumbell Samples; RTV S-5370 Dumbell Samples. All after 7 cycles ETO/Freon 12. Note increase in size of Sylgard 182 and Nitroso Rubber specimens from the original. Color Photo (Neg. #33012-67).

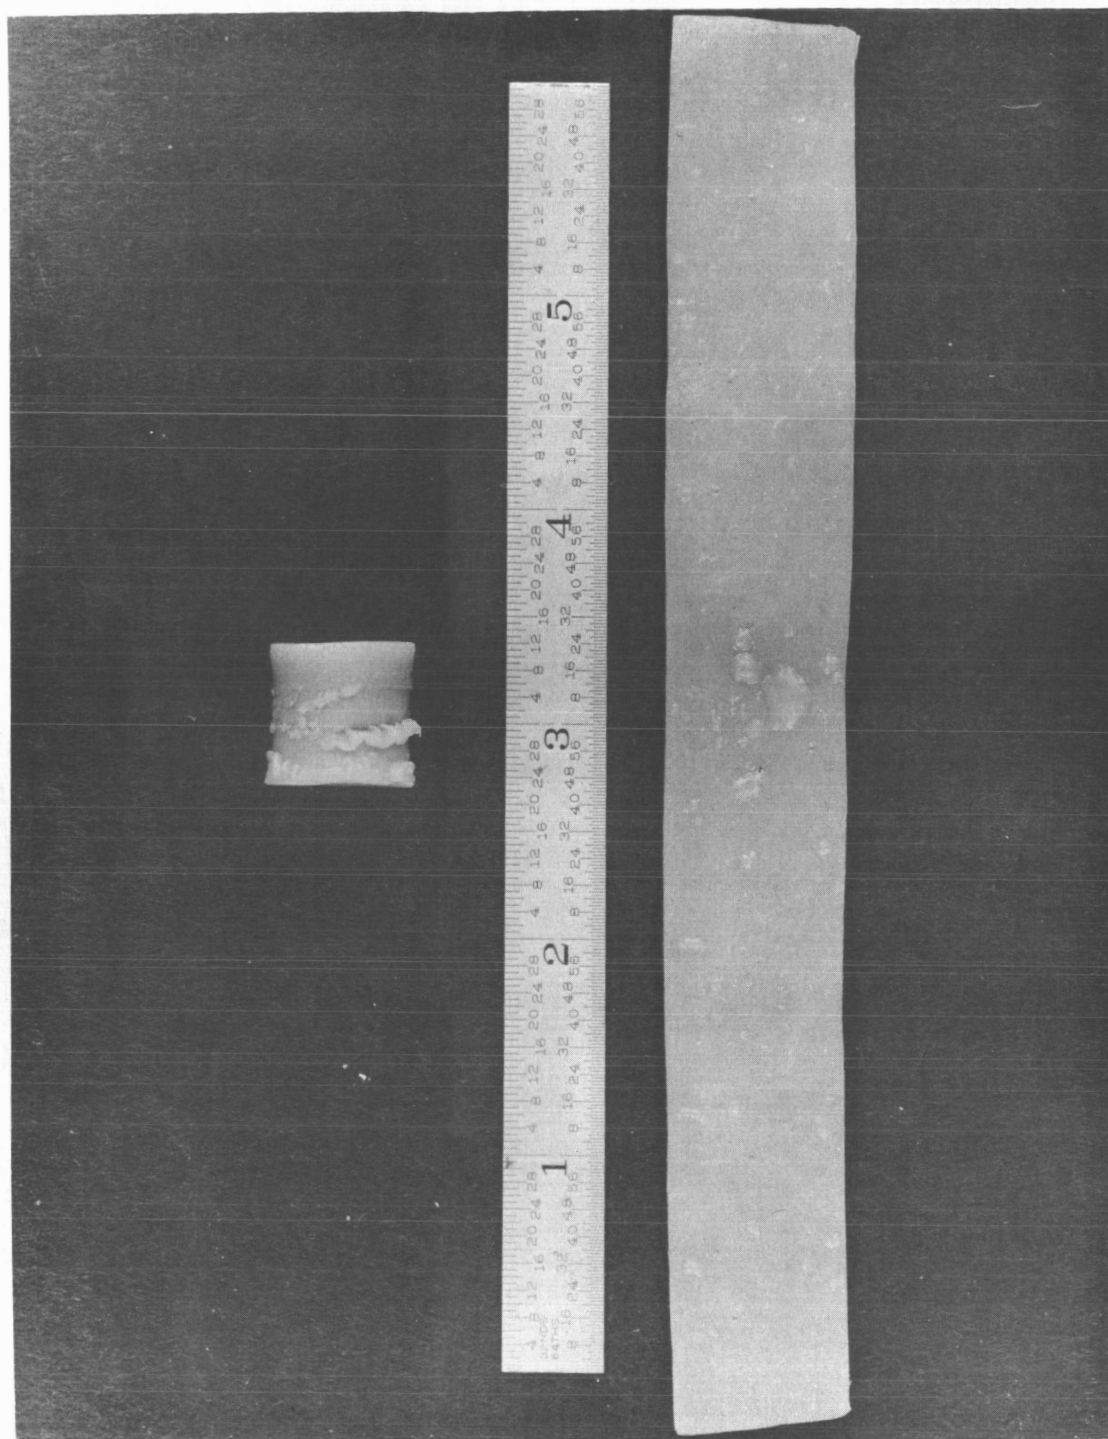
FIGURE 7. Nitroso Rubber after 7 cycles of ET0/Freon 12. The original size of the button was approximately 1/2" diameter X 1/2" Long. The sheet was approximately .025" thick X 1/2" wide X 3 3/4" Long originally. Note color change from dark green to light green. Color Photo (Neg. #33021-67).

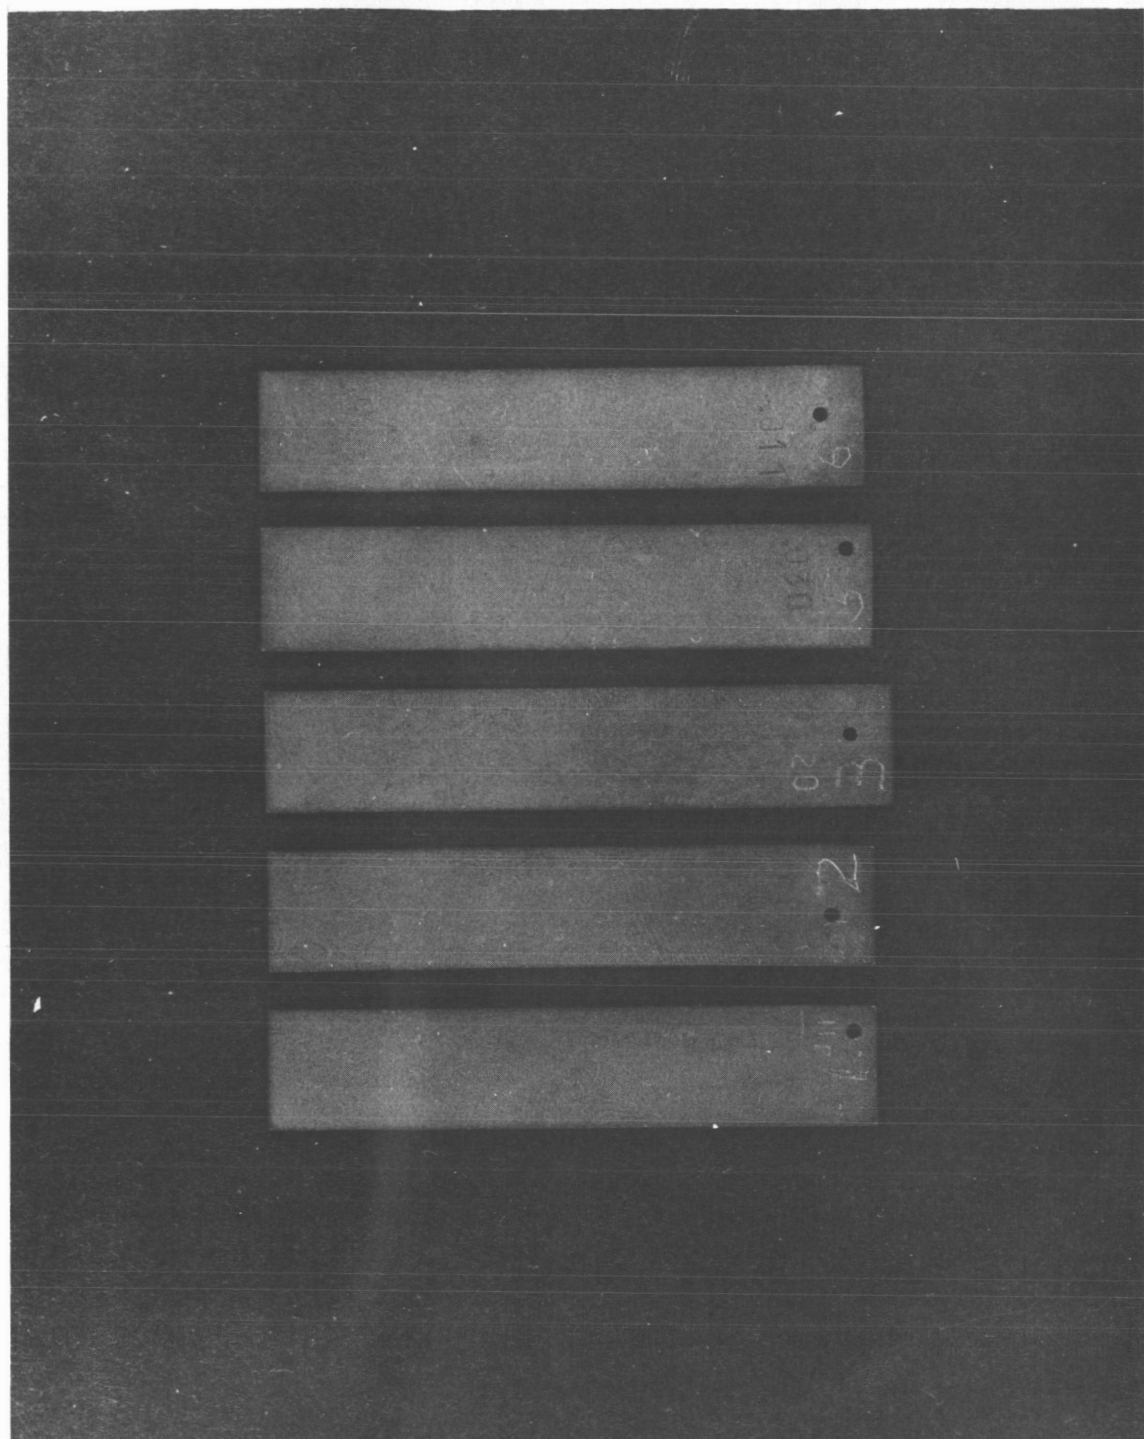
FIGURE 8. Aluminide Coatings before ET0/Freon 12. Color Photo (Neg. #32612-67)

The Aluminide Coatings (See Table 3 and Figures 8 and 9), which are utilized on the injector pintle tip and nozzle extension, showed practically no change in weight during the decontamination. Very slight visual changes were apparent, which were confirmed by microscopic examination. There is no evidence to indicate that difficulty will be encountered with this material.

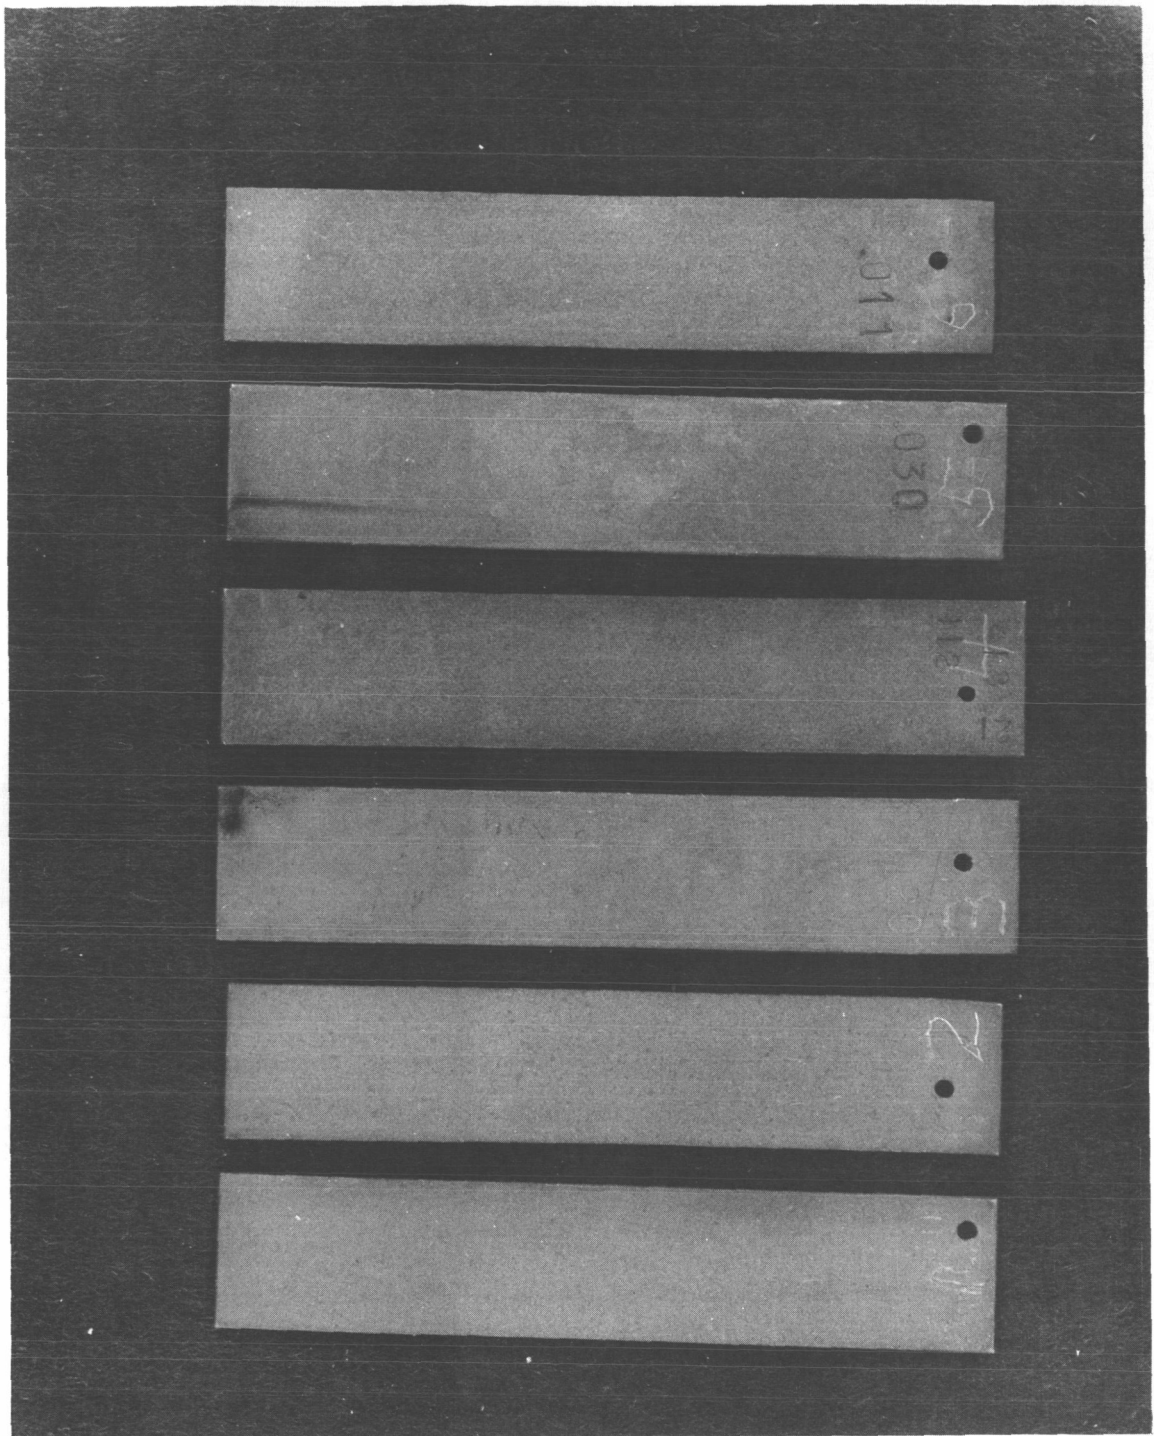
FIGURE 9. Aluminide Coatings after 7 cycles ET0/Freon 12. Note slight color changes from original in Figure 8. Color Photo (Neg. #33025-67).

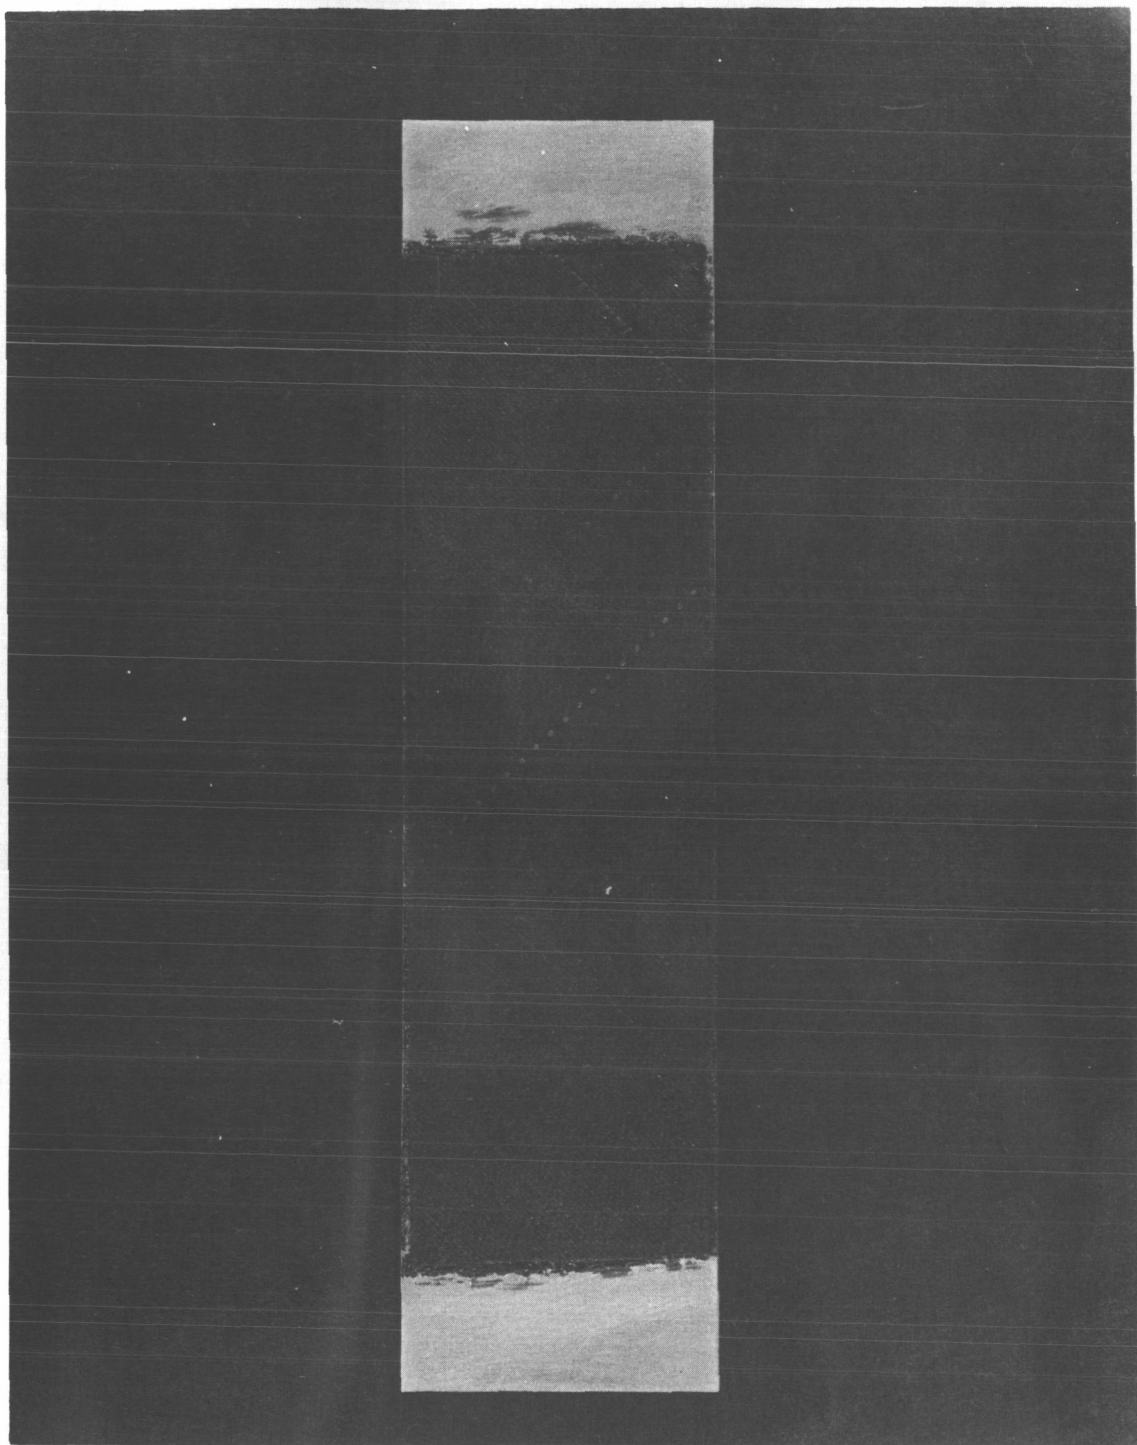
FIGURE 10. Fabroid Gimbal Bearing material before ET0/Freon 12. The material was bonded on to a piece of steel because its physical appearance could not be studied in a Gimbal Bearing. Color Photo (Neg. #33024-67).

The fabroid material in the Gimbal Bearing held up quite well in the decontaminant. (See Figures 10 and 11). No changes were observed, although the bearing friction seemed to increase slightly.

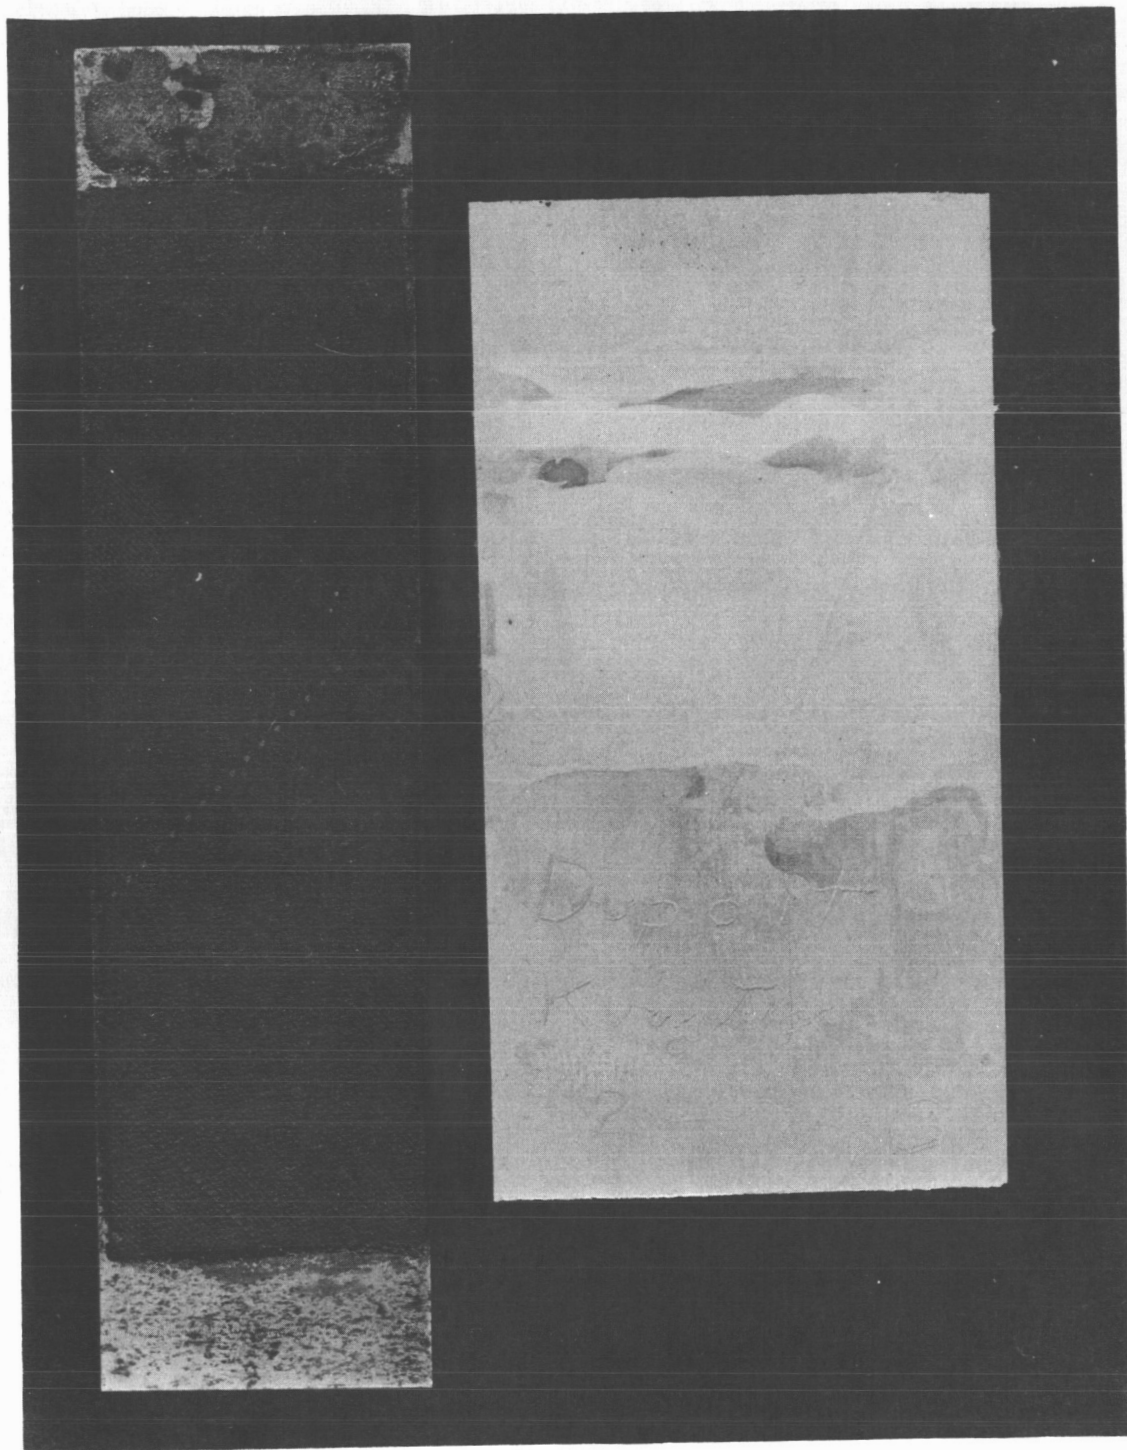
FIGURE 11. On the left, Fabroid Gimbal Bearing material after 7 cycles ET0/Freon 12. No change in the Fabroid material, although steel shows some corrosion. On the Right, DuPont Krytox 240-AC Grease after 7 cycles ET0/Freon 12. Material has become a little viscous but still maintains its lubricating properties. Color Photo (Neg. #33017-67).

DuPont Krytox 240-AC (Figures 11 and 13) lubrication material showed excellent resistance to the ETO/Freon 12 environment. Literature search compatibility studies conducted by the writer had indicated that 240-AC grease would not be compatible with ETO/Freon 12. It was predicted that the grease would lose its viscosity and thereby become useless for lubrication purposes. However, contrary to this prediction, the grease became heavier, if anything, maintaining its viscosity, thus retaining its lubrication value.

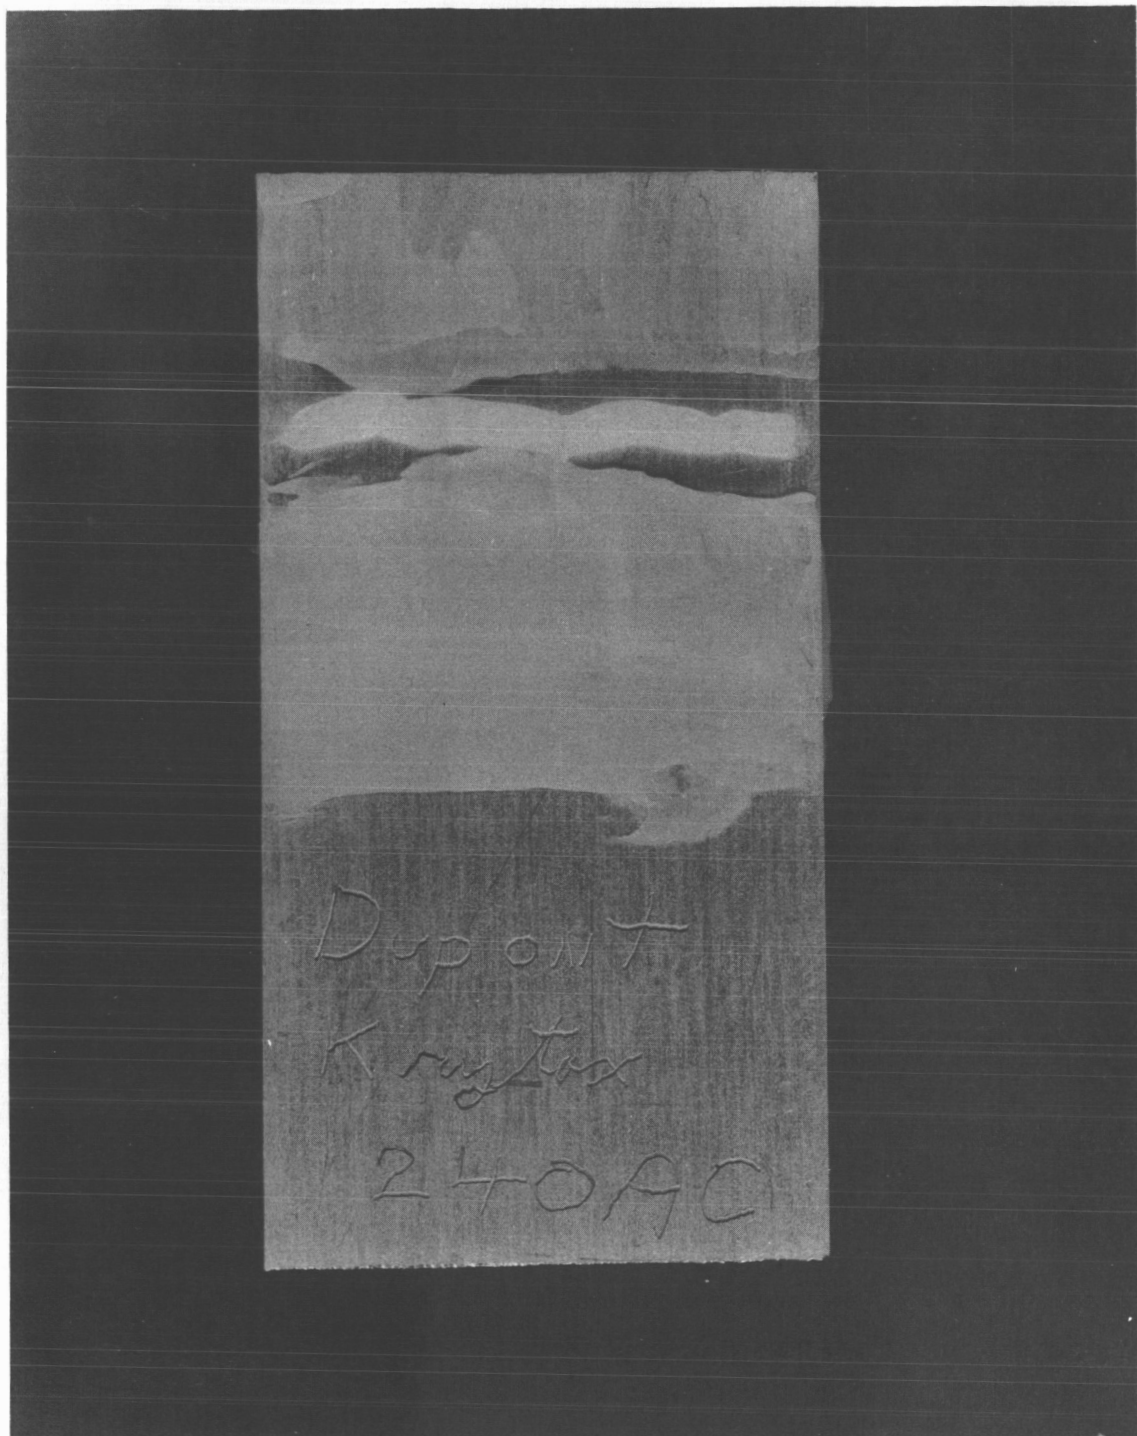
FIGURE 13. DuPont Krytox 240-AC Grease before ET0/Freon 12. Color Photo (Neg. #32890-67).
